**Flood Control Project Maintenance
Levee Inspections**
LMA District Cover Sheet
Spring 2017 Levee Inspection Results

Sutter Maintenance Yard Maintenance Area 0003

Levee Inspection Report By Mile - Spring 2017

Waterway	Bank	Unit Miles	Inspection Start/End	Inspector
Unit No. 01 Feather River	Right	5.11	04/06/2017 04/06/2017	Sterling York

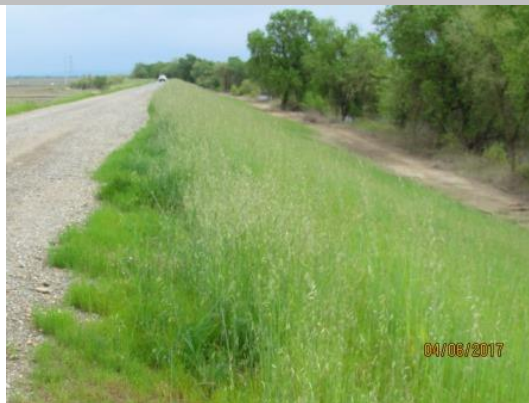
Photo 1 of 1 : SP_2017_MA0003_195_12_20170410_00031.jpg

LM Start	0.01	Rating **	M	Issue No.	12
LM End	5.11	Issue Type +	Ma	Location *	WS
Category	Earthen Levee			GPS Latitude/Longitude	
				Start	End
Item	Vegetation			38.897973 °	38.950881 °
				-121.617817 °	-121.585758 °
DWR ID	DWR_MA0003_01_s_2017_12				
Comment Code					
V1 : Control annual grass and weeds on the levee slopes and easements.					
Inspector Comment					
Annual grasses need to be maintained, Spring 2017.

View looking upstream of annual grasses that need to be maintained, Spring 2017.

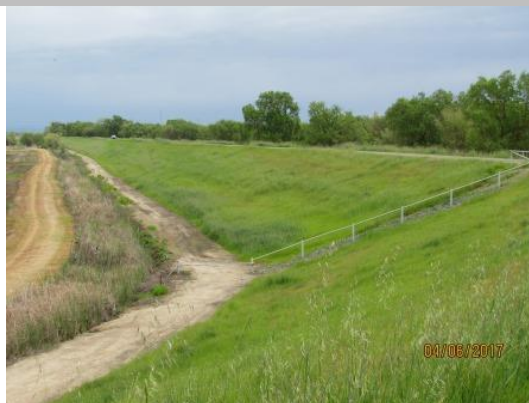
Photo 1 of 1 : SP_2017_MA0003_195_11_20170410_00030.jpg

LM Start	0.01	Rating **	M	Issue No.	11
LM End	5.11	Issue Type +	Ma	Location *	LS
Category	Earthen Levee			GPS Latitude/Longitude	
				Start	End
Item	Vegetation			38.897973 °	38.950881 °
				-121.617816 °	-121.585758 °
DWR ID	DWR_MA0003_01_s_2017_11				
Comment Code					
V1 : Control annual grass and weeds on the levee slopes and easements.					
Inspector Comment					
Annual grasses need to be maintained, Spring 2017.

View looking upstream of annual grasses that need to be maintained, Spring 2017.

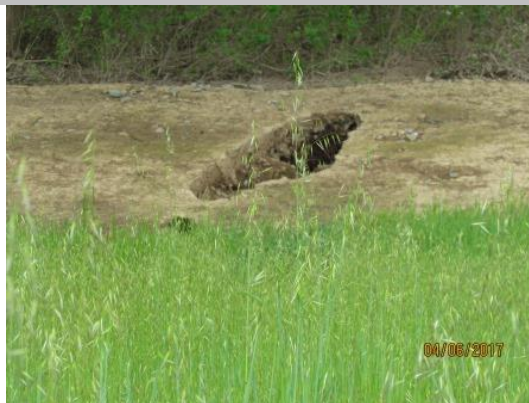
Photo 1 of 1 : SP_2017_MA0003_195_13_20170410_00032.jpg

LM Start	0.42	Rating **	M	Issue No.	13
LM End	0.42	Issue Type +	Ma	Location *	WS
Category	Earthen Levee			GPS Latitude/Longitude	
				Start	End
Item	Animal Control			38.900811 °	38.900811 °
				-121.611604 °	-121.611604 °
DWR ID	DWR_MA0003_01_s_2017_13				
Comment Code					
A1 : Exterminate rodents and backfill and compact or grout burrows.					
Inspector Comment					
A large hole on the waterside that look to be from a large animal needs repair, Spring 2017.

View of a large hole on the waterside that look to be from a large animal, Spring 2017.

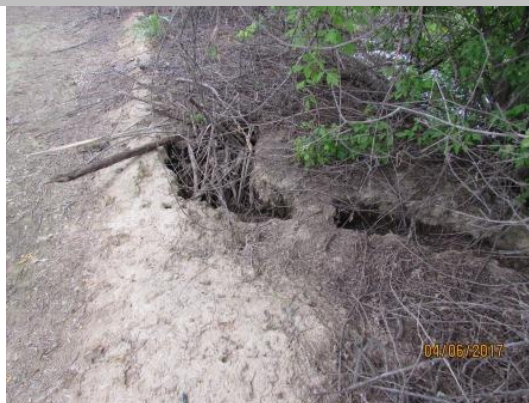
Photo 1 of 1 : SP_2017_MA0003_195_17_20170410_00033.jpg

LM Start	0.69	Rating **	M	Issue No.	17
LM End	0.69	Issue Type +	Ma	Location *	LS
Category	Earthen Levee			GPS Latitude/Longitude	
				Start	End
Item	Animal Control			38.903352 °	38.903352 °
				-121.607829 °	-121.607829 °
DWR ID	DWR_MA0003_01_s_2017_17				
Comment Code					
A1 : Exterminate rodents and backfill and compact or grout burrows.					
Inspector Comment					
A large hole on the lanside that look to be from a large animal needs to be repaired, Spring 2017.

View of a large hole on the landside that look to be from a large animal, Spring 2017.

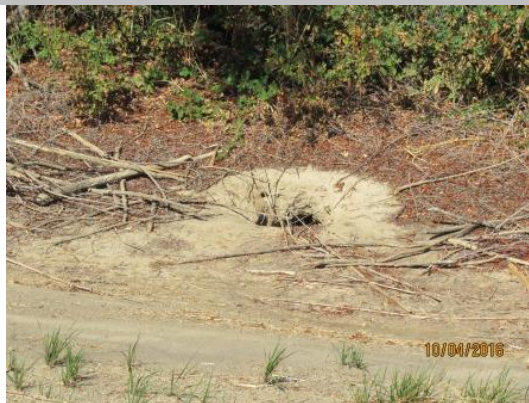
Photo 1 of 2 : SP_2017_MA0003_195_140_20170316_00013.jpg

LM Start	0.78	Rating **	M	Issue No.	140
LM End	0.78	Issue Type +	Ma	Location *	LS
Category	Earthen Levee			GPS Latitude/Longitude	
				Start	End
Item	Animal Control			38.903339 °	38.903339 °
				-121.606209 °	-121.606209 °
DWR ID	DWR_MA0003_01_f_2014_140				
Comment Code					
A3 : No rodents visible, but rodent burrows visible; need to backfill and compact or grout burrows.					
Inspector Comment					
There is a rodent hole on the landward toe road approximately 8" in diameter that needs to be repaired. Fall 2016.

This photo was taken from the landward levee slope near the toe road facing north looking at an approximately 8" rodent hole. Fall 2016.

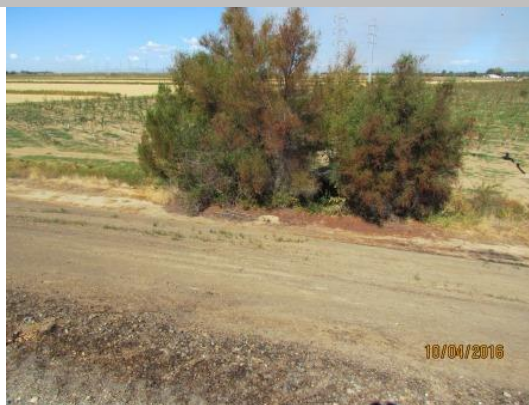
Photo 2 of 2 : SP_2017_MA0003_195_140_20170316_00014.jpg

This is another photo of the rodent hole to show its relationship to the levee toe, toe road, and drainage ditch. Fall 2016.

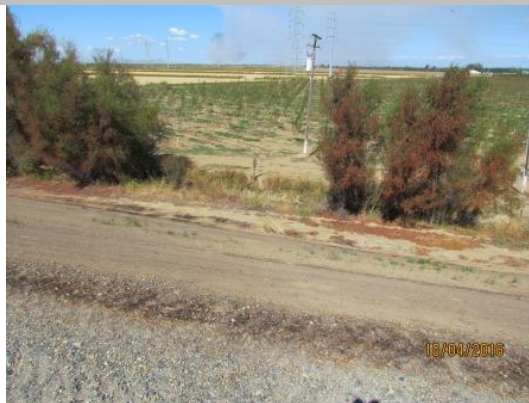
Photo 2 of 2 : SP_2017_MA0003_195_21_20170316_00012.jpg

LM Start	0.80	Rating **	M	Issue No.	21 (cont)	
LM End	0.80	Issue Type +	Ma	Location *	LS	
Category	Earthen Levee			GPS Latitude/Longitude		
				Start		End
Item	Animal Control			38.903277 °		38.903277 °
				-121.605864 °		-121.605864 °
DWR ID	DWR_MA0003_01_f_2016_21					
Comment Code						
A3 : No rodents visible, but rodent burrows visible; need to backfill and compact or grout burrows.						
Inspector Comment						
Repair animal hole at landside levee toe. Fall 2016.

View from the crown of where this hole is. Fall 2016.

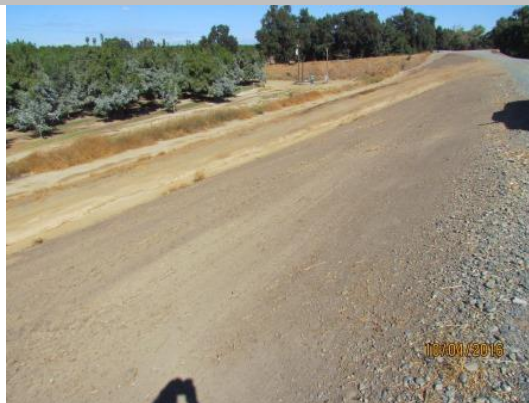
Photo 1 of 1 : SP_2017_MA0003_195_14_20170316_00005.jpg

Rodent holes were backfilled and no longer exist at this location. Fall 2016.

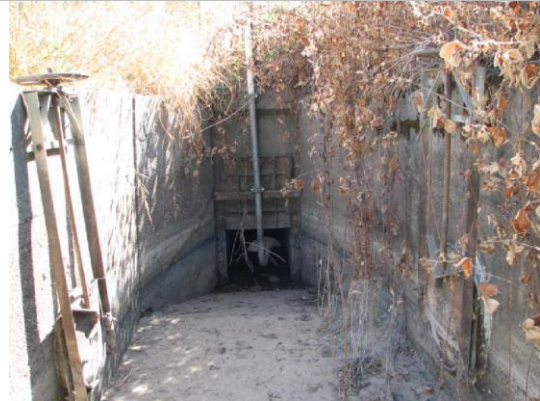
Photo 1 of 3 : UCIP_SP_2017_51477_64668.jpg

FS_ID:51477
DS_ID:17088
EP_NO: 3284
Repair Type: Urgent
Crossing Status: Found
UCIP Comments: 4/11/2017 There was a cavity collapse above the pipe alignment on the WS slope during January 2017 high water event. Cavity was filled with rock to prevent further levee damage during the high water season. Further inspection will be needed on this crossing to determine the cause of the collapse. Recommend having an internal camera inspection done. Erosion happening around the WS concrete vault. (DWR Sutter Yard- A Freitag)10/10/2016 LS pipe end was mostly submerged so could not verify the connectivity between the LS headwall and WS vault. B Lackberries and still overgrown on WS. (DWR Sutter Yard - a Freitag)4/18/2016 WS vault is being overgrown with blackberries. They should be sprayed and cleared back. No other problems were noticeable with this crossing.5/12/2015 Only the right flapgate appeared to be abandoned. The left and middle flap gates were flowing water during the last inspection.11/17/2014 Same as last inspection.5/14/2014 Same as last inspection.10/30/2013 Same as last inspection.5/21/2013 Pumping plant was running and filling concrete vault on WS toe through the left flap gate and then flowing through levee pipe and filling irrigation ditch on LS. Left and middle flap gates appear to be connected to pumps and right gate appears abandoned. Recommend contacting owner to get more details.10/10/2012 Pumping plant has been disconnected from levee. Need to determine if abandonment is appropriate or if this is now a gravity drain with flap gate.

32X32 box culvert on LS toe in Concrete U shaped channel with slide gate.

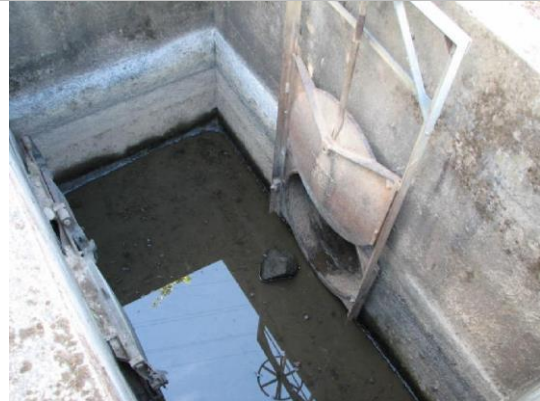
Photo 2 of 3 : UCIP_SP_2017_51477_64667.jpg

FS_ID:51477
DS_ID:17088
EP_NO: 3284
Repair Type: Urgent
Crossing Status: Found
UCIP Comments: 4/11/2017 There was a cavity collapse above the pipe alignment on the WS slope during January 2017 high water event. Cavity was filled with rock to prevent further levee damage during the high water season. Further inspection will be needed on this crossing to determine the cause of the collapse. Recommend having an internal camera inspection done. Erosion happening around the WS concrete vault. (DWR Sutter Yard- AFreitag)10/10/2016 LS pipe end was mostly submerged so could not verify the connectivity between the LS headwall and WS vault. BLackberries and still overgrown on WS.(DWR Sutter Yard - afreitag)4/18/2016 WS vault is being overgrown with blackberries. They should be sprayed and cleared back. No other problems were noticeable with this crossing.5/12/2015 Only the right flapgate appeared to be abandoned. The left and middle flap gates were flowing water during the last inspection.11/17/2014 Same as last inspection.5/14/2014 Same as last inspection.10/30/2013 Same as last inspection.5/21/2013 Pumping plant was running and filling concrete vault on WS toe through the left flap gate and then flowing through levee pipe and filling irrigation ditch on LS. Left and middle flap gates appear to be connected to pumps and right gate appears abandoned. Recommend contacting owner to get more details.10/10/2012 Pumping plant has been disconnected from levee. Need to determine if abandonment is appropriate or if this is now a gravity drain with flap gate.

8-foot X 14-foot concrete box on WS toe with slide gate and 3 abandoned flap gates.

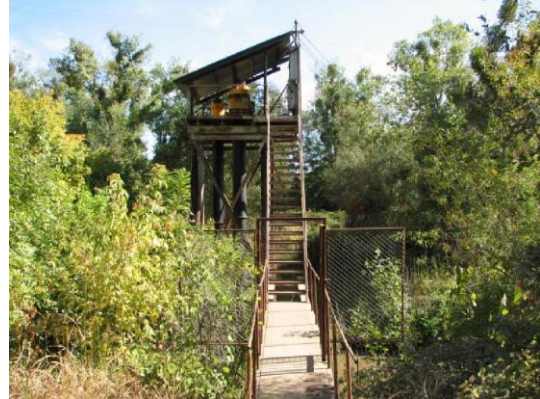
Photo 3 of 3 : UCIP_SP_2017_51477_64666.jpg

FS_ID:51477
DS_ID:17088
EP_NO: 3284
Repair Type: Urgent
Crossing Status: Found
UCIP Comments: 4/11/2017 There was a cavity collapse above the pipe alignment on the WS slope during January 2017 high water event. Cavity was filled with rock to prevent further levee damage during the high water season. Further inspection will be needed on this crossing to determine the cause of the collapse. Recommend having an internal camera inspection done. Erosion happening around the WS concrete vault. (DWR Sutter Yard- A Freitag)10/10/2016 LS pipe end was mostly submerged so could not verify the connectivity between the LS headwall and WS vault. B Lackberries and still overgrown on WS. (DWR Sutter Yard - a Freitag)4/18/2016 WS vault is being overgrown with blackberries. They should be sprayed and cleared back. No other problems were noticeable with this crossing.5/12/2015 Only the right flapgate appeared to be abandoned. The left and middle flap gates were flowing water during the last inspection.11/17/2014 Same as last inspection.5/14/2014 Same as last inspection.10/30/2013 Same as last inspection.5/21/2013 Pumping plant was running and filling concrete vault on WS toe through the left flap gate and then flowing through levee pipe and filling irrigation ditch on LS. Left and middle flap gates appear to be connected to pumps and right gate appears abandoned. Recommend contacting owner to get more details.10/10/2012 Pumping plant has been disconnected from levee. Need to determine if abandonment is appropriate or if this is now a gravity drain with flap gate.

Pumping plant on WS toe at small slough. Pipes no longer connected to concrete box on WS toe.

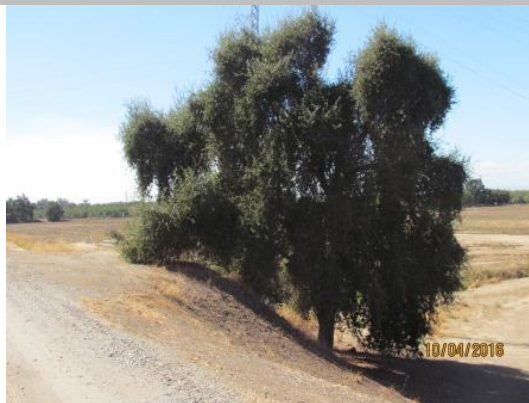
Photo 1 of 1 : SP_2017_MA0003_195_15_20170316_00006.jpg

View of tree at a turnout that needs to have it limbs trimmed for visibility and access, landside looking downstream. Fall 2016.

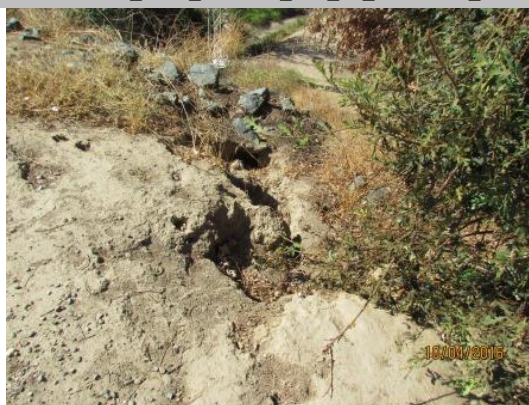
Photo 1 of 1 : SP_2017_MA0003_195_18_20170316_00008.jpg

LM Start	2.18	Rating **	A/W	Issue No.	18
LM End	2.18	Issue Type +	Ma	Location *	LS
Category	Earthen Levee			GPS Latitude/Longitude	
				Start	End
Item	Animal Control			38.911869 °	38.911869 °
				-121.586093 °	-121.586093 °
DWR ID	DWR_MA0003_01_s_2015_18				
Comment Code					
A3 : No rodents visible, but rodent burrows visible; need to backfill and compact or grout burrows.					
Inspector Comment

View of rodent holes that need to be backfilled, No evidence of rodents during inspection. Fall 2016.

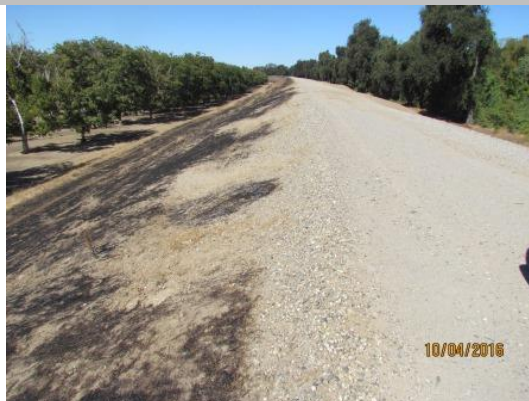
Photo 1 of 1 : SP_2017_MA0003_195_20_20170316_00010.jpg

LM Start	3.20	Rating **	A/W	Issue No.	20
LM End	3.20	Issue Type +	Ma	Location *	LS
Category	Earthen Levee			GPS Latitude/Longitude	
				Start	End
Item	Slope Stability			38.925909 °	38.925909 °
				-121.585401 °	-121.585401 °
DWR ID	DWR_MA0003_01_s_2015_20				
Comment Code					
S1 : Repair slope instability.					
Inspector Comment

View of the inconsistent slope that makes the crown narrower were it dips in and out, but no evidence of slope erosion or sloughing. Fall 2016.

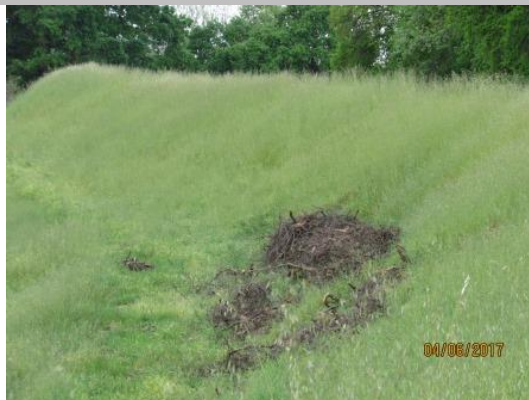
Photo 1 of 1 : SP_2017_MA0003_195_22_20170410_00034.jpg

LM Start	3.48	Rating **	M	Issue No.	22
LM End	3.48	Issue Type +	En	Location *	LS
Category	Earthen Levee			GPS Latitude/Longitude	
				Start	End
Item	Encroachments			38.929128 °	38.929128 °
				-121.588412 °	-121.588412 °
DWR ID	DWR_MA0003_01_s_2017_22				
Comment Code					
PR : Prunings					
Inspector Comment					
Pruning's need to be removed from landside slope, Spring 2017.

View looking upstream of pruning's that need to be removed from landside slope, Spring 2017.

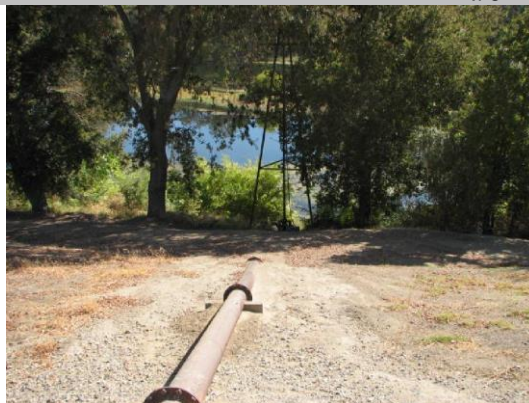
Photo 1 of 3 : UCIP_SP_2017_51481_64672.jpg

FS_ID:51481
DS_ID:17087
EP_NO: 1730
Repair Type: Non-Urgent
Crossing Status: Found
UCIP Comments: 4/11/2017 Big dig out/depression still present at the LS toe. Pipe is set to be replaced during the SBFCA project so depression should be repaired then. (DWR Sutter Yard - AFreitag)10/10/2016 Depression is still present at the LS toe but appears that it was dug out on purpose.(DWR Sutter Yard - afreitag)4/18/2016 Big depression on LS toe along the pipe alignment. 5/12/2015 Crossing appears to be in good condition. No noticeable issues to report.11/17/2014 Same as last inspection.5/14/2014 Same as last inspection.10/30/2013 Same as last inspection.5/21/2013 SBFCA project recommends replacing in accordance with title 23. Same as last inspection.
FIELD_STRUCT_DESC: 12-inch steel asphalt coated irrigation pipe through the levee, 4.5 feet below the crown. Gate valve and pump located on the waterside (WS). 24-inch concrete standpipe located on the landside (LS) toe has been degraded to ground elevation and filled in with soil. Pipe remains intact. Steel tower over pump is located on the WS. (Permit No. 1730, 1959 - Robert L. Crandall). [Additional Reference(s): DWR Levee Log, 2005].

Pipe, pump, and tower on WS slope/toe.

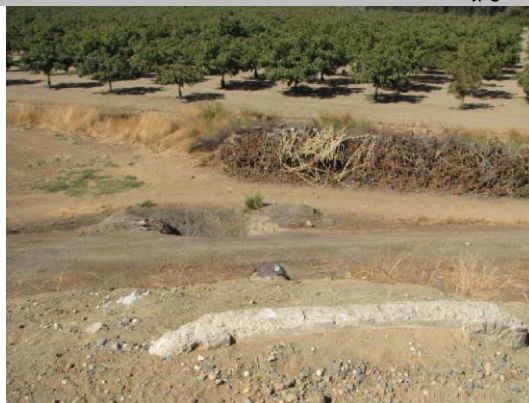
Photo 2 of 3 : UCIP_SP_2017_51481_64671.jpg

Pipe at LS shoulder showing exposed concrete cutoff wall.

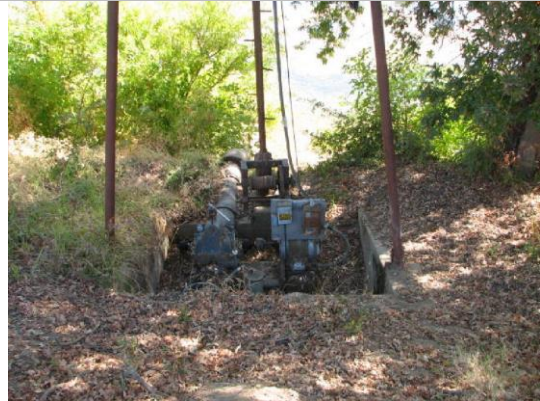
Photo 3 of 3 : UCIP_SP_2017_51481_64670.jpg

Comment Code					
Inspector Comment					
FS_ID:51481 DS_ID:17087 EP_NO: 1730 Repair Type: Non-Urgent Crossing Status: Found UCIP Comments: 4/11/2017 Big dig out/depression still present at the LS toe. Pipe is set to be replaced during the SBFCA project so depression should be repaired then. (DWR Sutter Yard - AFreitag)10/10/2016 Depression is still present at the LS toe but appears that it was dug out on purpose.(DWR Sutter Yard - afreitag)4/18/2016 Big depression on LS toe along the pipe alignment. 5/12/2015 Crossing appears to be in good condition. No noticeable issues to report.11/17/2014 Same as last inspection.5/14/2014 Same as last inspection.10/30/2013 Same as last inspection.5/21/2013 SBFCA project recommends replacing in accordance with title 23. Same as last inspection. FIELD_STRUCT_DESC: 12-inch steel asphalt coated irrigation pipe through the levee, 4.5 feet below the crown. Gate valve and pump located on the waterside (WS). 24-inch concrete standpipe located on the landside (LS) toe has been degraded to ground elevation and filled in with soil. Pipe remains intact. Steel tower over pump is located on the WS. (Permit No. 1730, 1959 - Robert L. Crandall). [Additional Reference(s): DWR Levee Log, 2005]. FS Date: 4/12/2017 9:16:41 AM

Pump at WS toe with tower over top and concrete U shaped headwall.

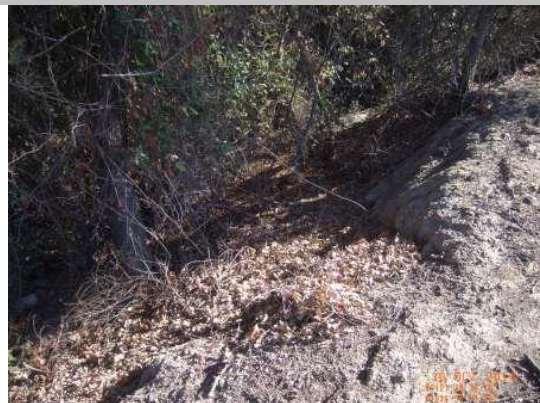
Photo 1 of 2 : SP_2017_MA0003_195_1_20170316_00001.jpg

LM Start	4.15	Rating **	M	Issue No.	1
LM End	4.18	Issue Type +	Ma	Location *	WS
Category	Supplemental			GPS Latitude/Longitude	
				Start	End
Item	2015 USACE Erosion Survey, DRAFT			38.937451 °	38.937937 °
				-121.588512 °	-121.588471 °
DWR ID	DWR_MA0003_01_s_2016_1				
Comment Code					
Inspector Comment					
2013 - Minor toe scour causing gradual erosion of bank slope. Site is within ecological reserve. 2015: Last observed in 2013. [2015 Site ID: FHR_12-3_R]

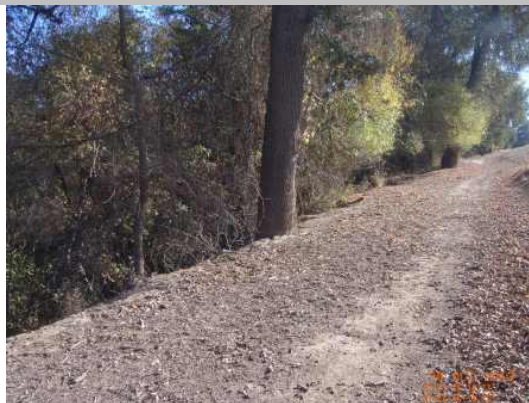
Photo 2 of 2 : SP_2017_MA0003_195_1_20170316_00002.jpg

LM Start	4.15	Rating **	M	Issue No.	1 (cont)	
LM End	4.18	Issue Type +	Ma	Location *	WS	
Category	Supplemental			GPS Latitude/Longitude		
				Start		End
Item	2015 USACE Erosion Survey, DRAFT			38.937451 °	38.937937 °	
				-121.588512 °	-121.588471 °	
DWR ID	DWR_MA0003_01_s_2016_1					
Comment Code						
Inspector Comment						
2013 - Minor toe scour causing gradual erosion of bank slope. Site is within ecological reserve. 2015: Last observed in 2013. [2015 Site ID: FHR_12-3_R]

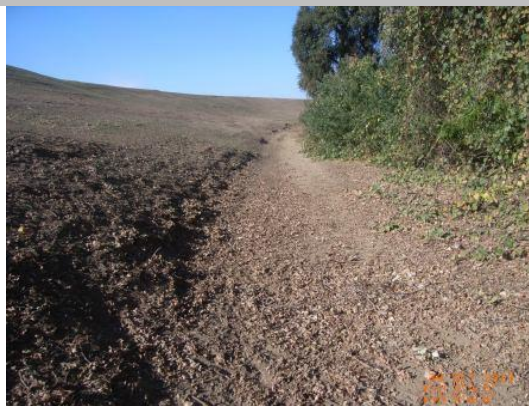
Photo 1 of 2 : SP_2017_MA0003_195_2_20170316_00003.jpg

LM Start	4.71	Rating **	M	Issue No.	2
LM End	4.76	Issue Type +	Ma	Location *	WS
Category	Supplemental			GPS Latitude/Longitude	
				Start	End
Item	2015 USACE Erosion Survey, DRAFT			38.945188 °	38.945958 °
				-121.586096 °	-121.586394 °
DWR ID	DWR_MA0003_01_s_2016_2				
Comment Code					
Inspector Comment					
2013 - Minor toe scour causing gradual erosion into the bank slope.					
2015: Last observed in 2013. [2015 Site ID: FHR_12-8_R]
